Manhole Inspection Summary

Manhole # S51K__010MH

Insp Date: **4/15/08 3:26 PM**

Location Address: **2901 fait av**

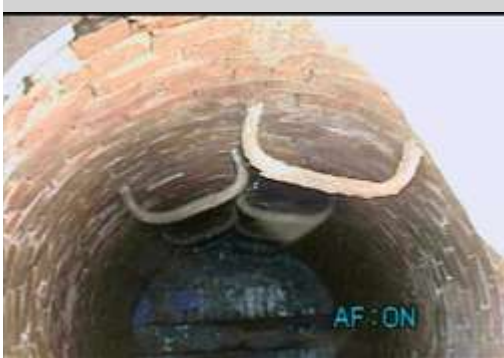
Defect 2

Steps Count: **7** Missing: **0** ☒ **Corroded**

debris, corroded stairs

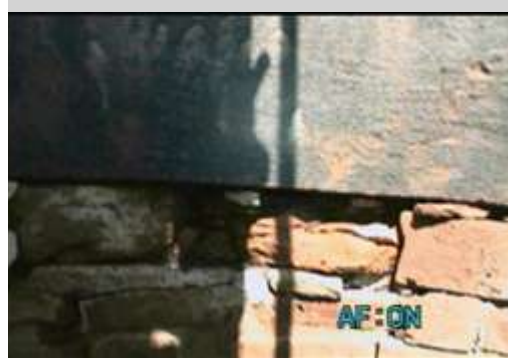
Defect 1

Condition: ☐ Sound ☐ Cracked ☐ Root Intrusion ☒ **Loose Brick** ☒ **Deteriorated**

loose brick in frame adjustment, chimney deteriorated

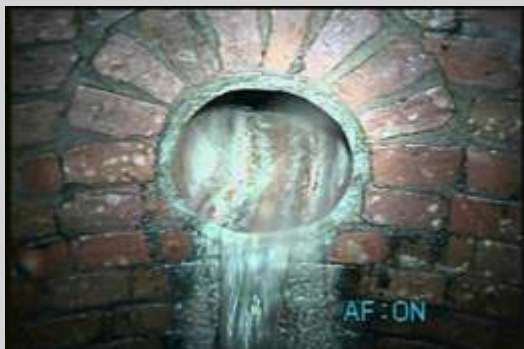
6 O'Clock Inflow

Drop: Outside Direct

Drop Condition: Partly Clogged
